### Safety factors

MANDANIS ANGEWANDTE MECHANIK GMBH

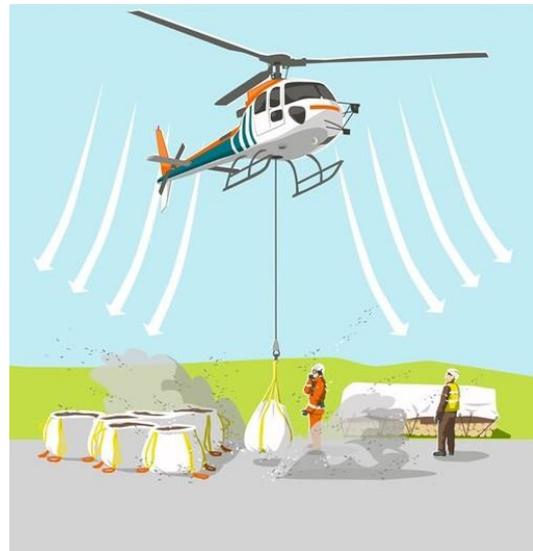
Illustration from: *Nine Essential Rules for Helicopter Ground Staff. Instruction Manual*, Suva [Swiss National Accident Insurance Fund]

As an example, take the load suspension device for helicopter transport, commonly known as the suspension cable.
